## **Middle Bear Canyon Erosion Investigation, Catalina Mountains, Tucson Arizona.**

Carried out by LTRR students spring semester, 2000.

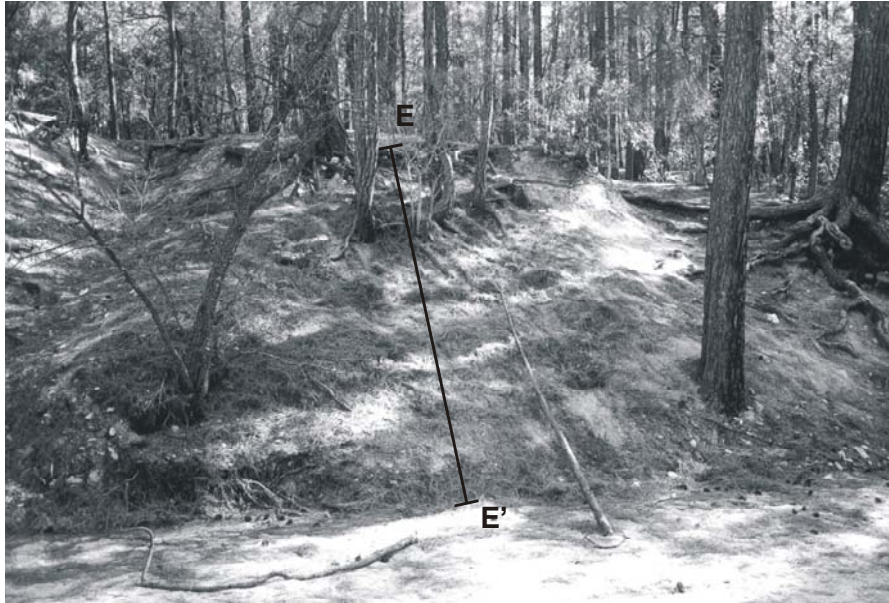
The group of twisted trees near profile "E" probably began growth on the high bank which was undercut and slumped in the 1850s - resulting in the twisted forms as the trees re-oriented to vertical. These trees began growing in the 1830s or 40s (age estimated when correcting for coring height). Tree size and tree age were not well related as these trees proved similar in age to much larger individuals above and below that had not been affected by the bank slump.

Profile "E" with twisted trees on fallen bank section.

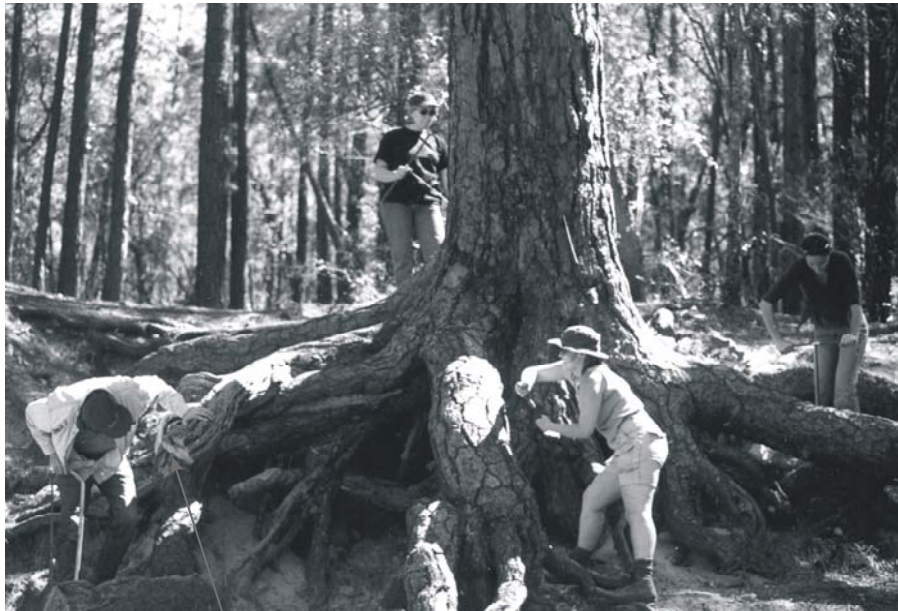
The large tree with the massive expose roots provided evidence of erosion prior to 1850. A large root was wounded on its upper surface by fire in 1819. By 1851 enough erosion had occurred to expose the bottom and it was scarred by a fire in 1851 on its lower surface.

Tree pith >1760

Root, wounded on top: 1819  
scarred on bottom: 1851
