West Brattleboro Apartments

925 and 929 Western Avenue

A dendrochronological examination

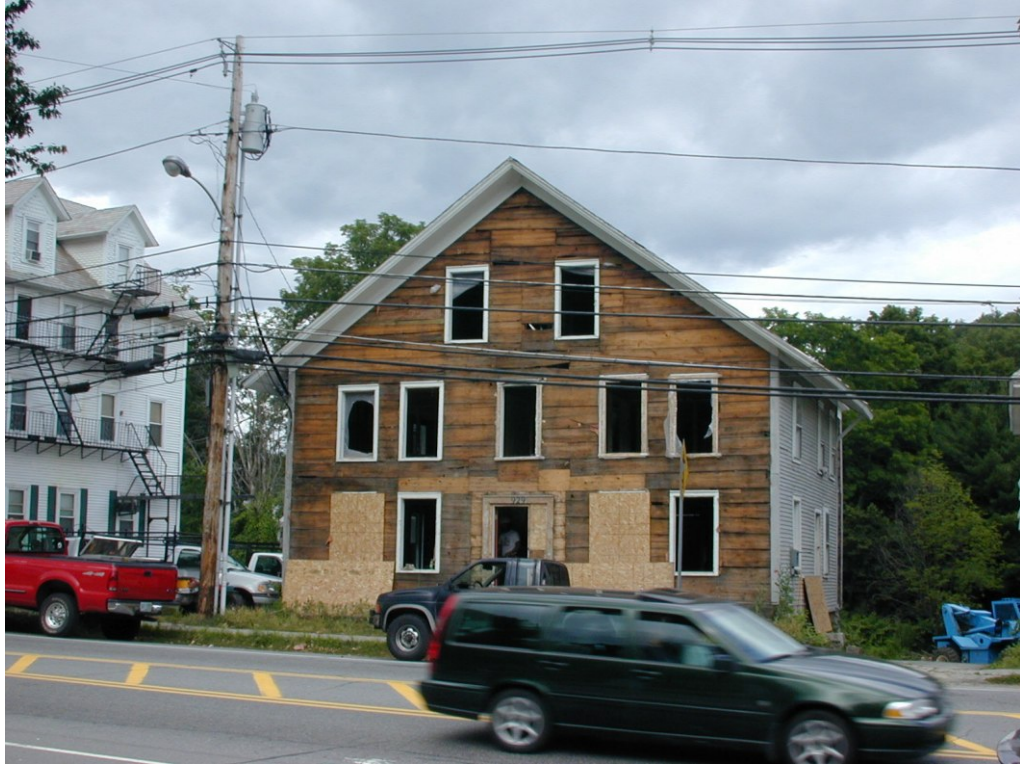
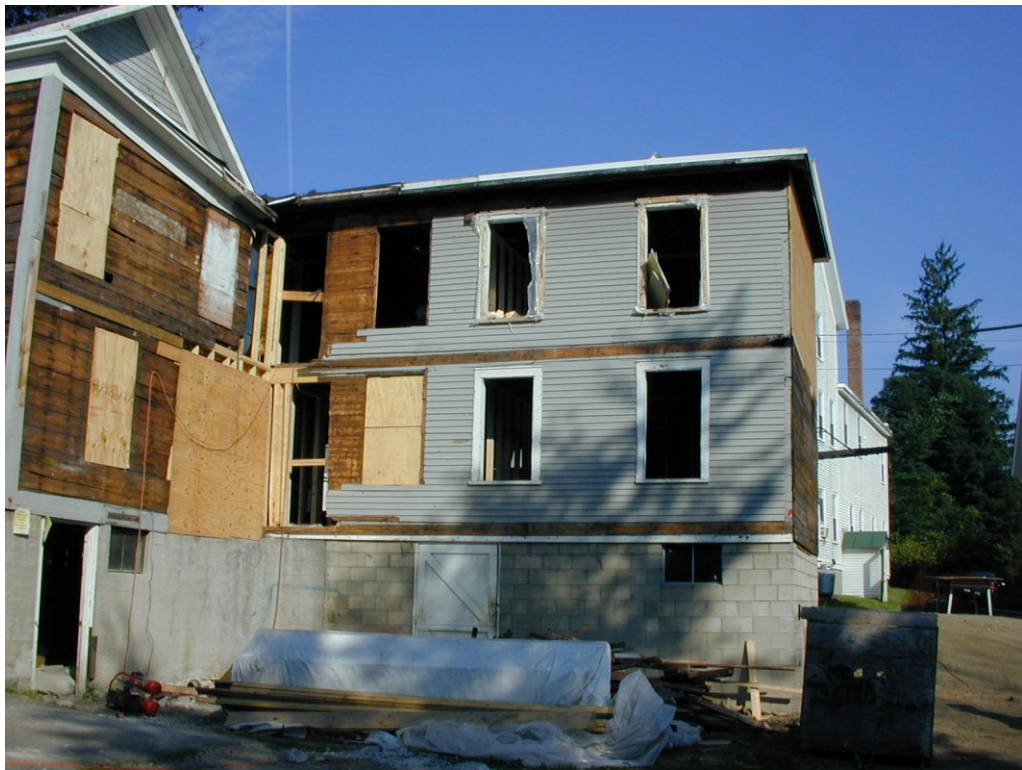
Front and rear views of #929.

The front 2 ½ story portion of #929 provided many samples from oak and hemlock framing timbers, posts, and sheathing boards. Bark, or “cutting” dates from this material were consistently 1836 with a single date of 1835 and one of 1837. This suggests a construction date of 1837 for this portion of the structure. All timber and boards from this portion were either hewn (posts, beams), or sawn on an “up-and-down” mill, consistent with this date.

The northwest two-story section in the rear was constructed of circular sawn material in a balloon-frame construction style. Boards and framing material dated to the 1860s and a single cutting date of 1872 was obtained from this material suggesting construction in 1873.

The “shed style” addition on the northeast end was sheathed in up-and-down sawn boards suggesting construction prior to 1850. No material was obtained that clearly originated in this section of the structure, thus no construction date is offered.

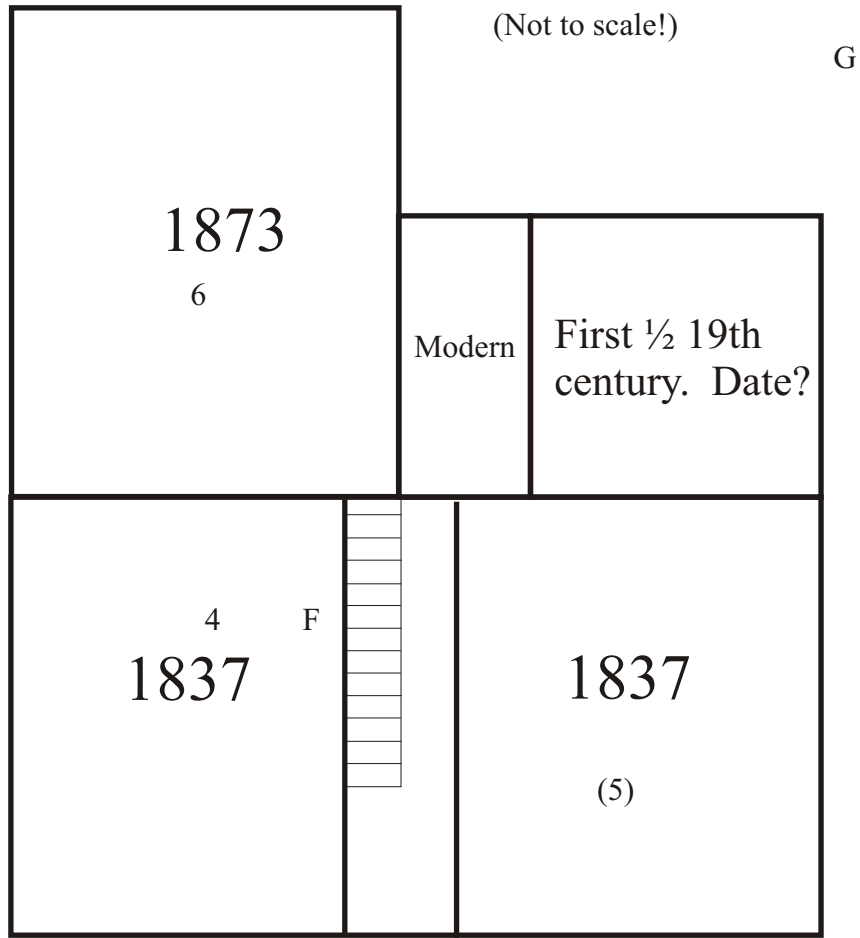
Building #2 (929 Western Ave.)

Ground Floor

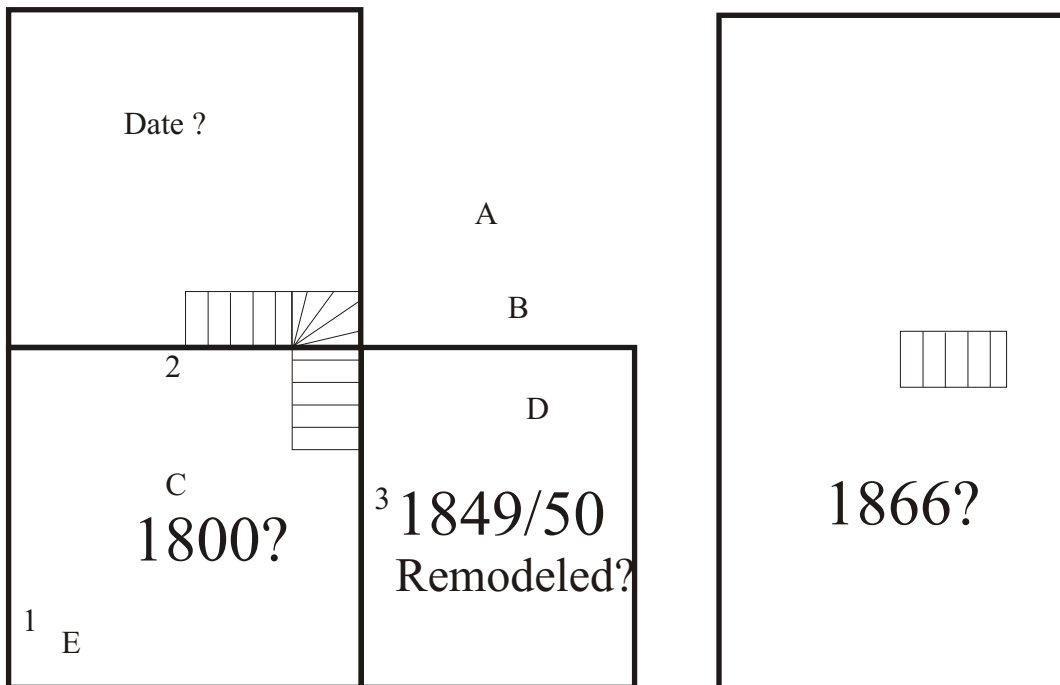
Building #1 (925 Western Ave.)

Ground Floor

Upper Floor

Key to sampling numbers:

1. Oak brace 1569-1720. No cutting date.
2. Short core from ceiling support beam. Possible cutting date of 1799.
3. Cores and pieces from slab wall studs cut in 1849 and 1850.
4. General context of oak joists and frame timbers cut in 1836.
5. Beam end from basement. Cut in 1836. No context.
6. General context of circular sawn boards dating to the 1860s and early 70s.

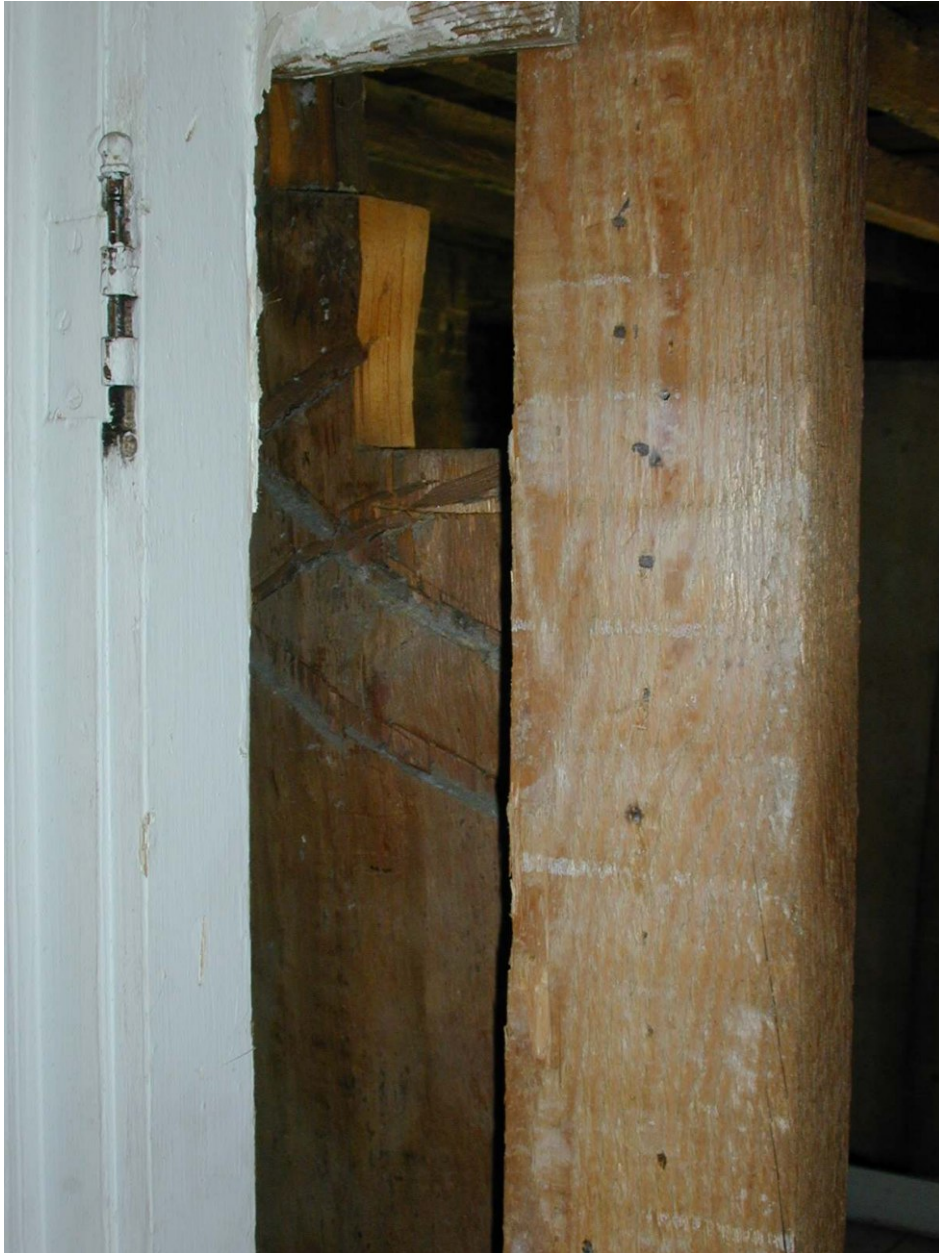
“W” carved in slab wood stud cut in 1849, east room of 925.

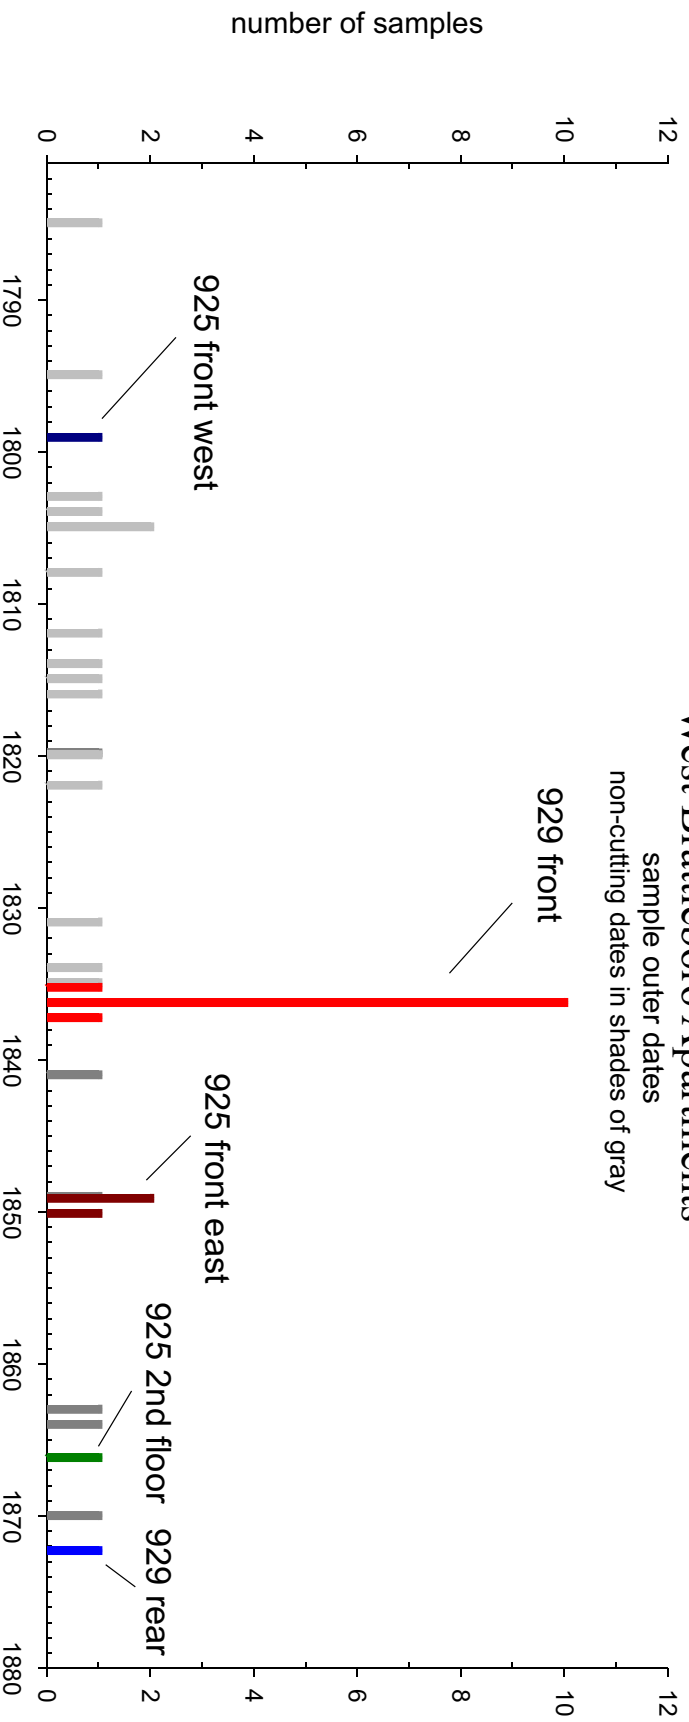
sample outer dates
non-cutting dates in shades of gray

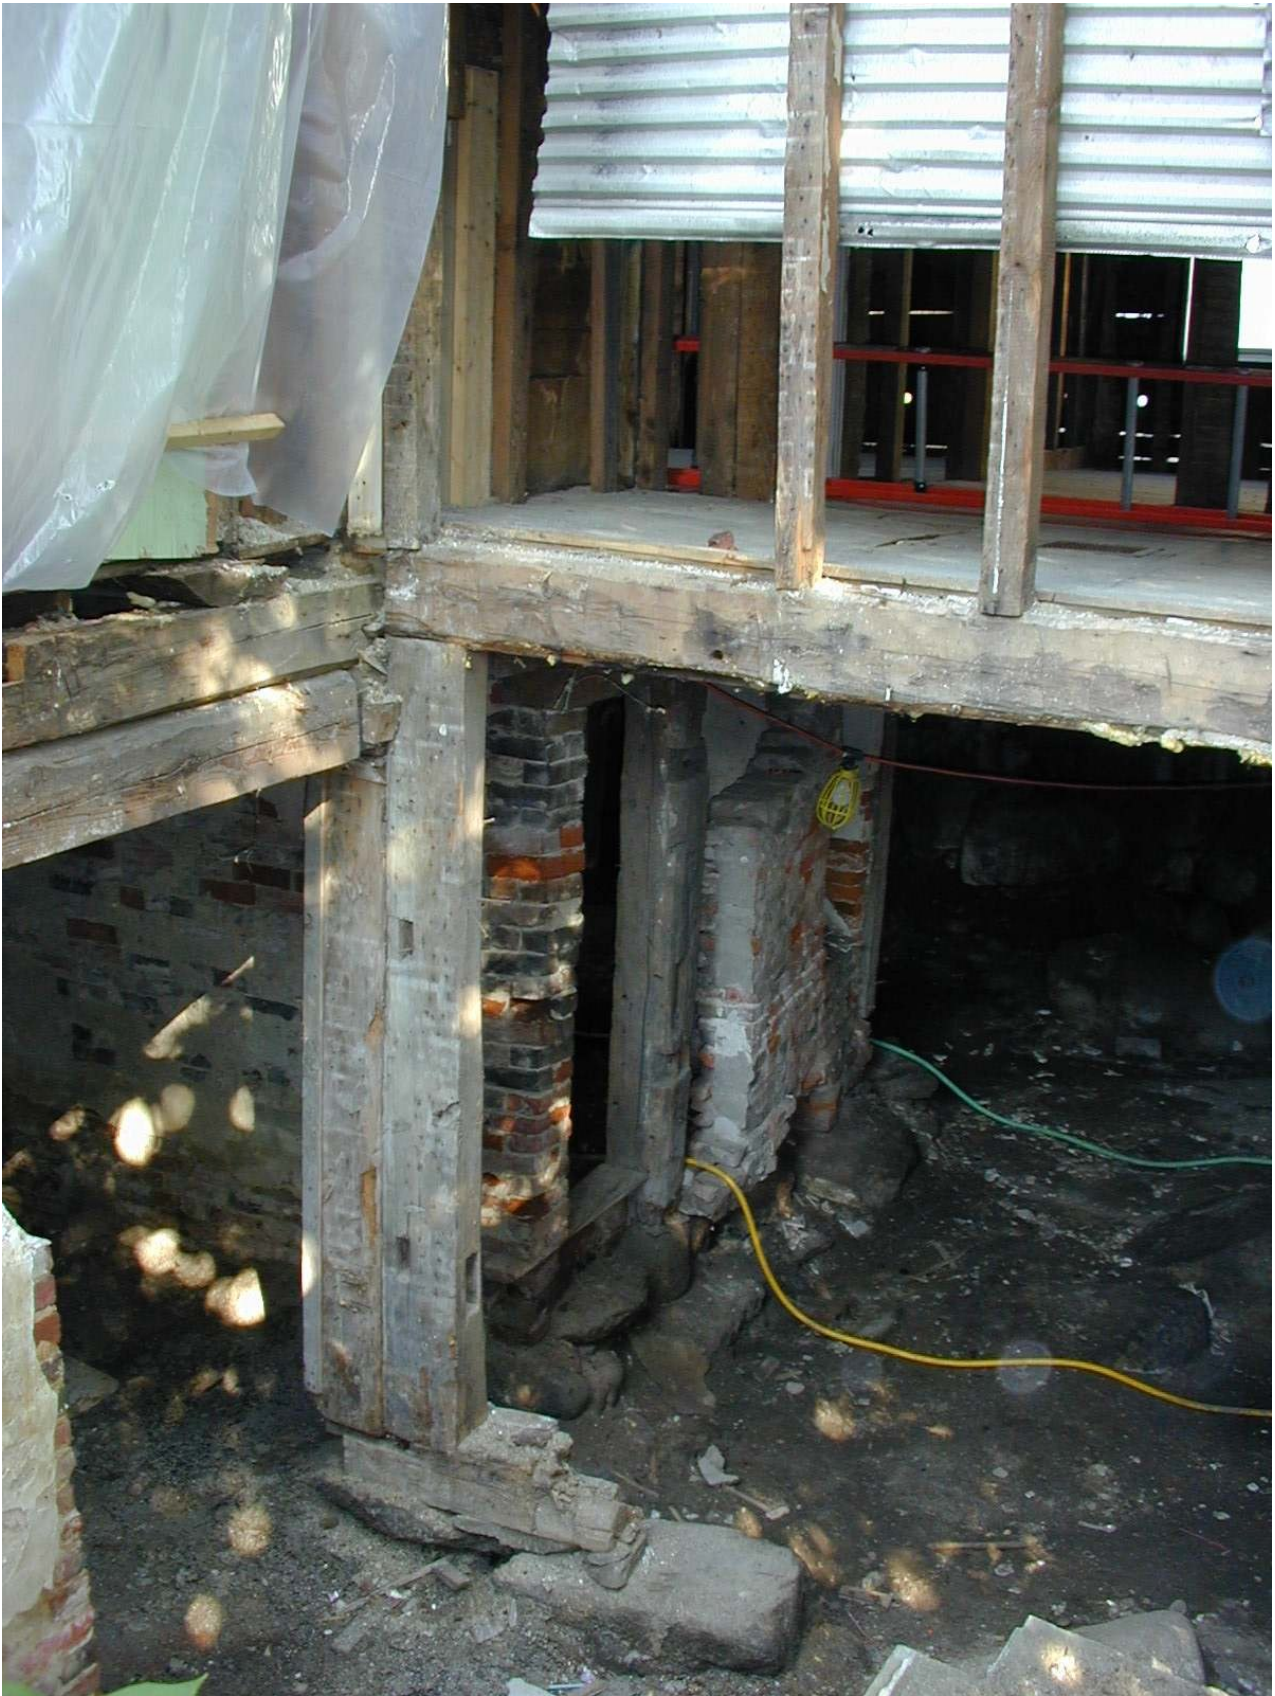
(A.) View of rear of #925 showing re-used timbers shoring up floor.

The construction of #925 suggested a complex history of additions and utilization of re-cycled timbers. The southwestern street level room appeared the oldest based on construction style (post and beam, very wide floor boards). The southeastern portion appeared to have been constructed of re-used timbers and had been renovated using slab wood for wall studs. Samples from these dated to 1848 and 1849 (cutting dates). A plaster lath wall exposed behind these slab studs, on the east end of the room, demonstrates an earlier incarnation. This room seemed to have been added to the western end. The timbers used for shoring in the basement were all re-cycled post and beam material of unknown provenance. It was suggested to me that portions of the structures had been moved to the site from elsewhere and this seemed entirely plausible.

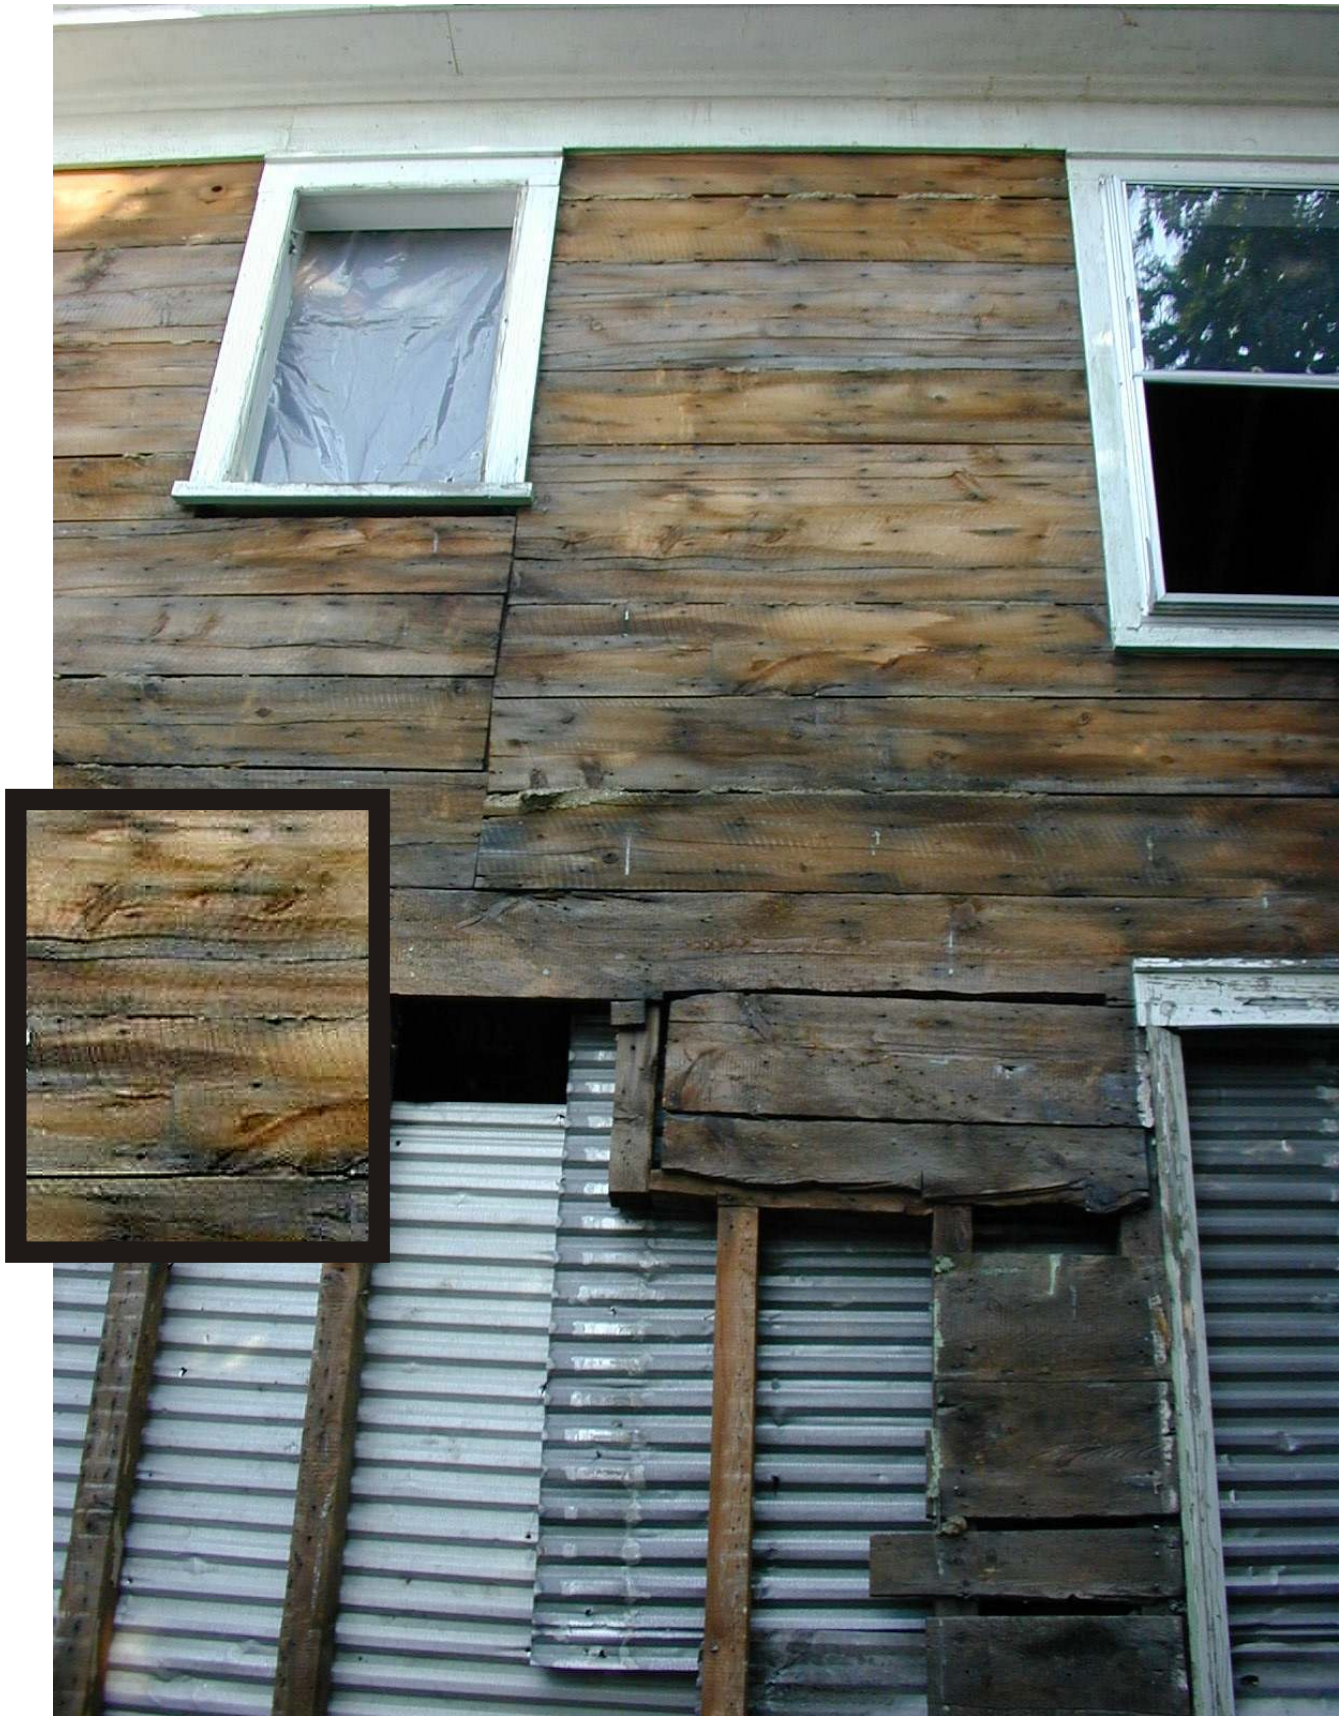
(B.) View of back of #925 showing circular sawn siding boards that sheath the second story.

The upper floor of 925 was entirely sheathed in circular sawn material and appeared to me to have been added to the lower structure - perhaps re-using the roof timbers once the frame had been added. The roof, as on #929, was slate over shake. A single board from the upper story had a cutting date of 1866, summer, suggesting construction of the upper level that year. However a single sample, without firm context, is not sufficient to establish this.

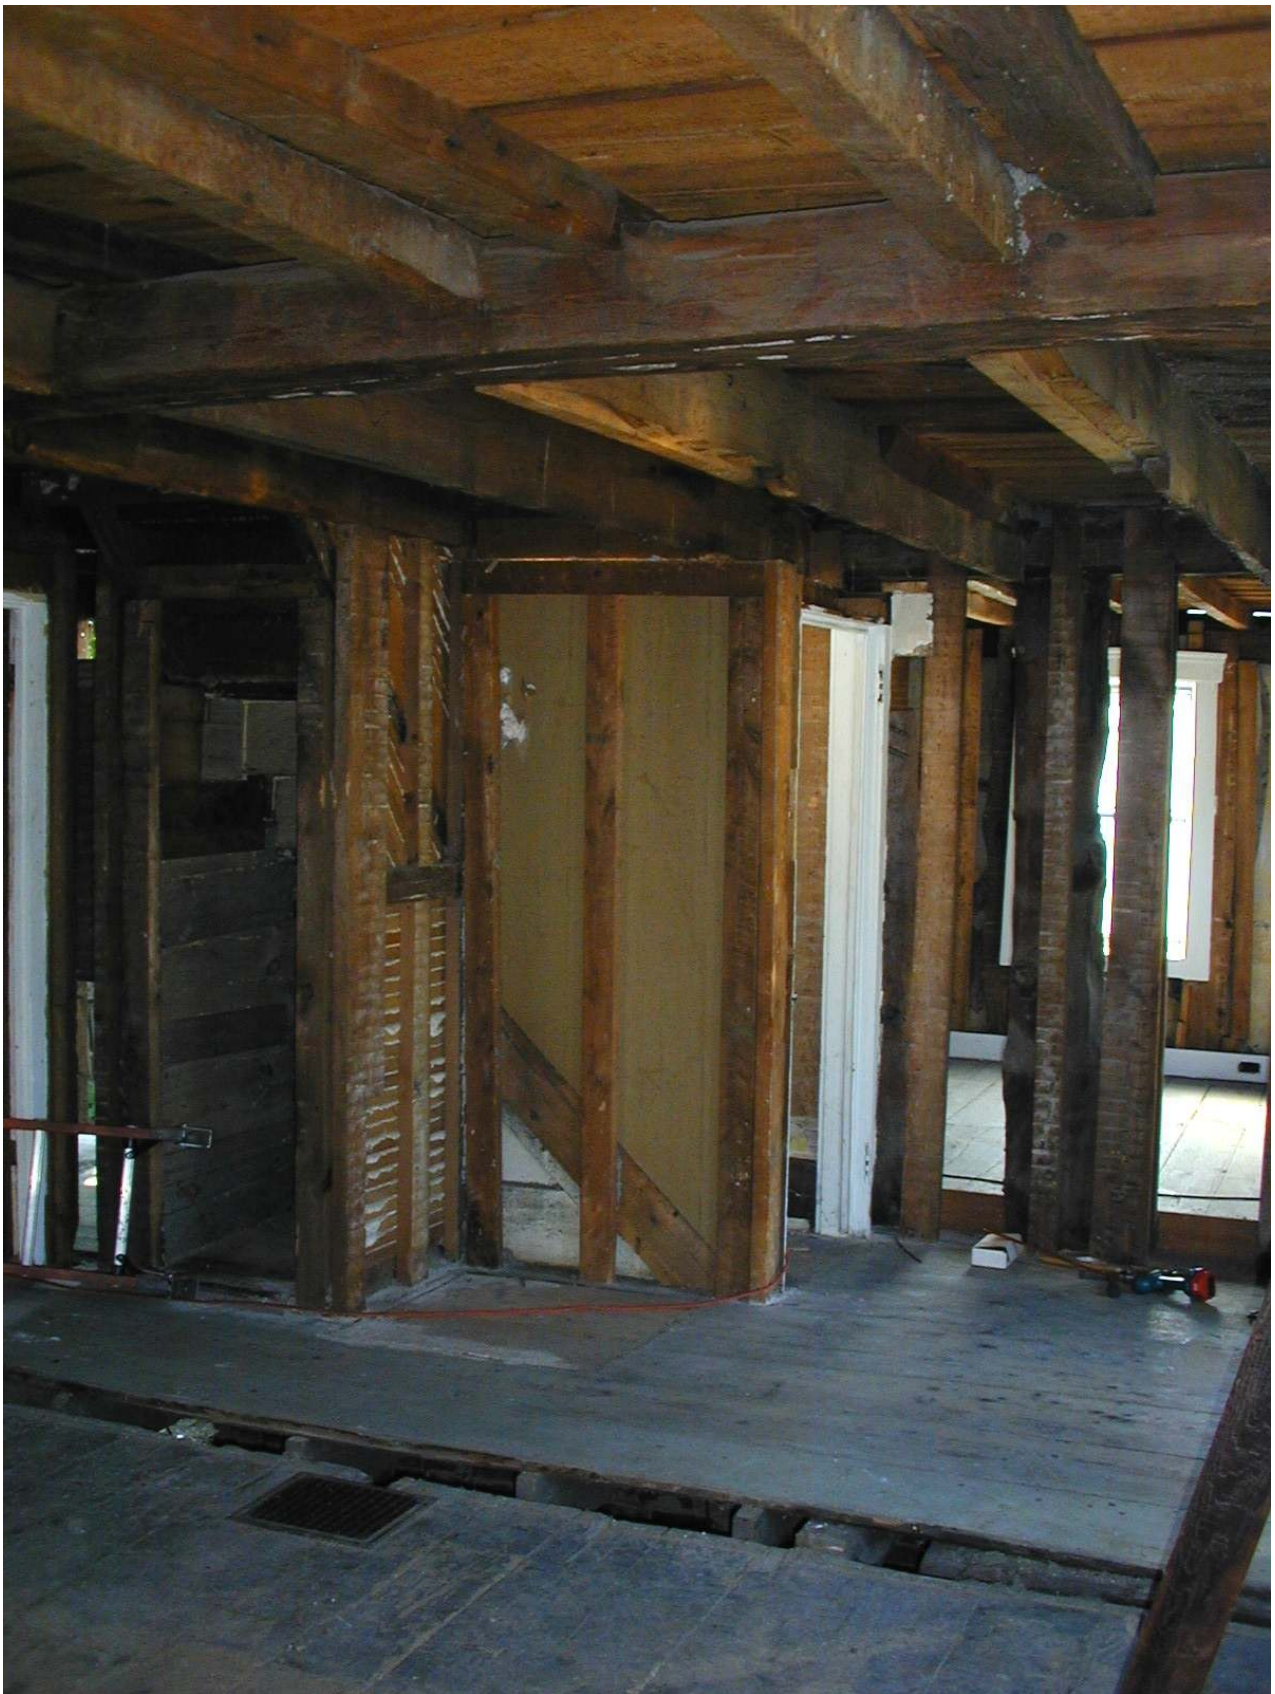
(C.) View through the front portion of #925 showing timber frame ceiling and joins in floor.

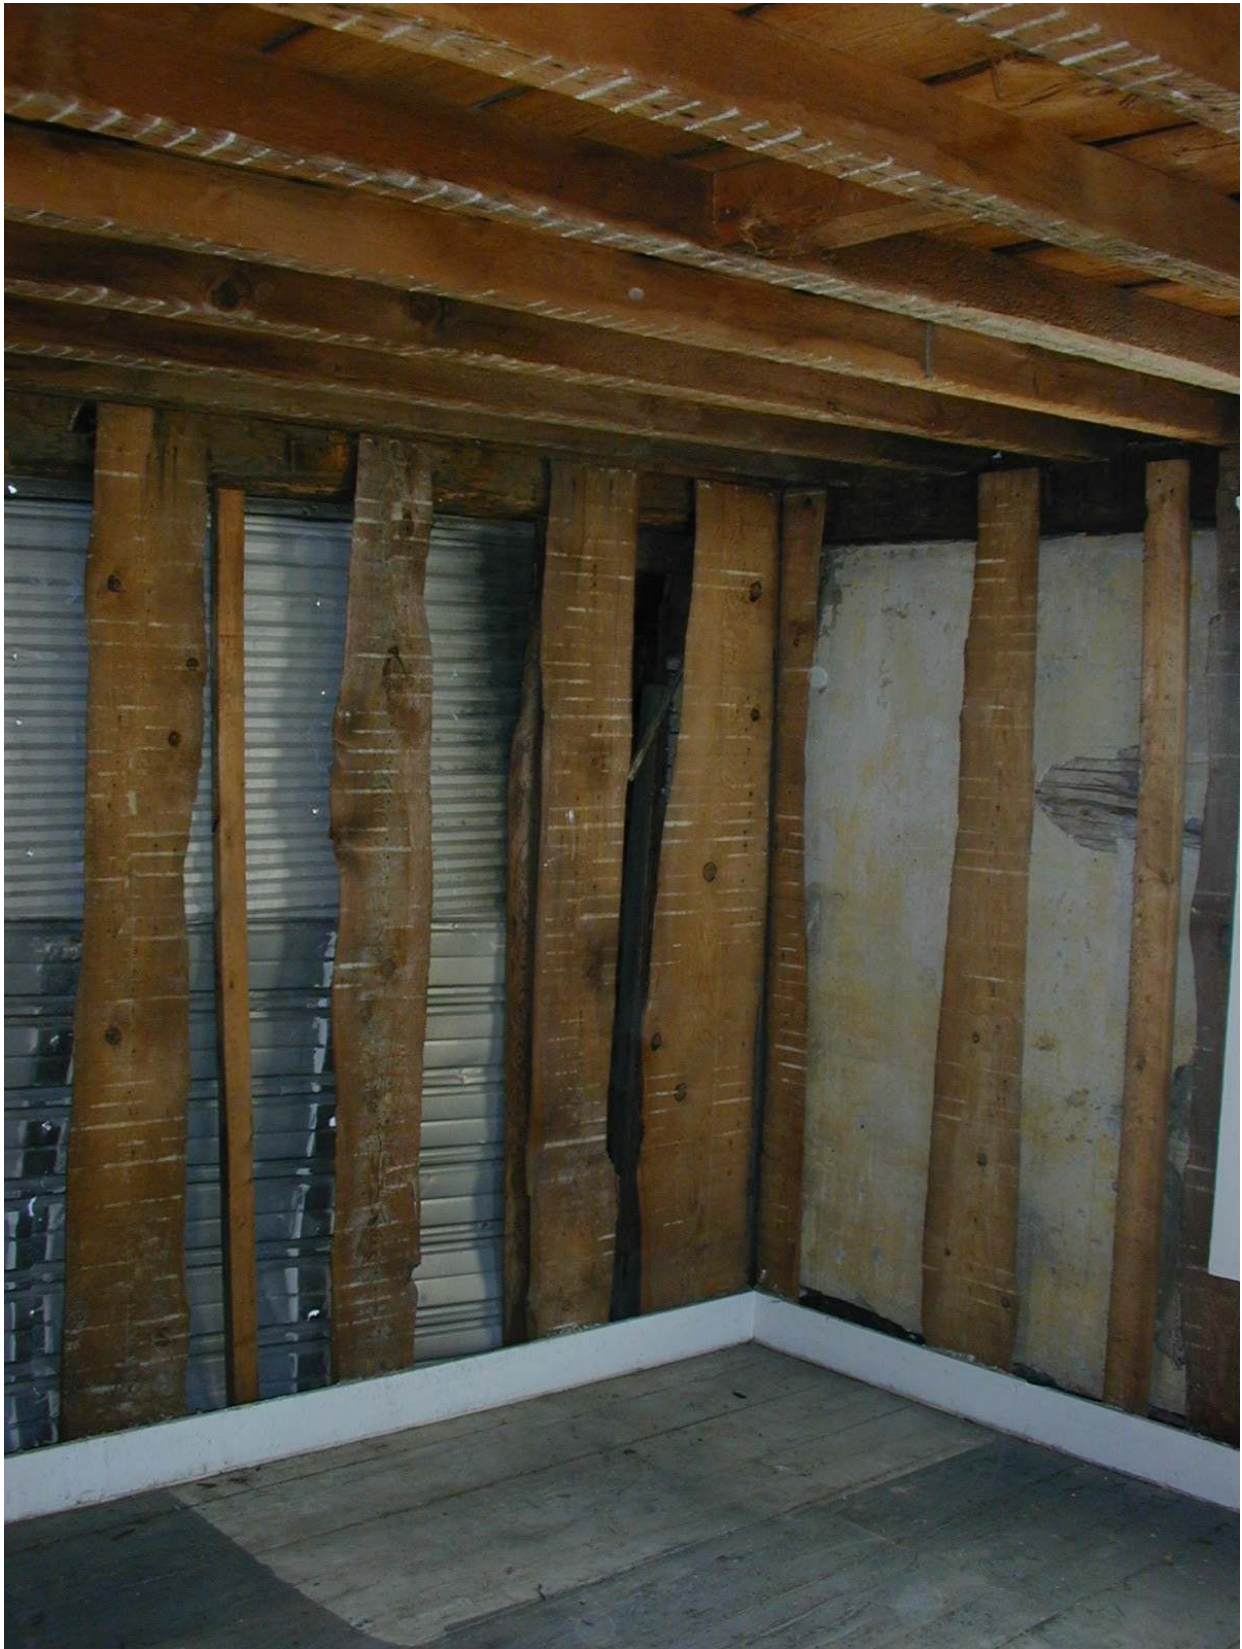
(D.) Slab wood wall studs cut in 1849 in the east room of #925.

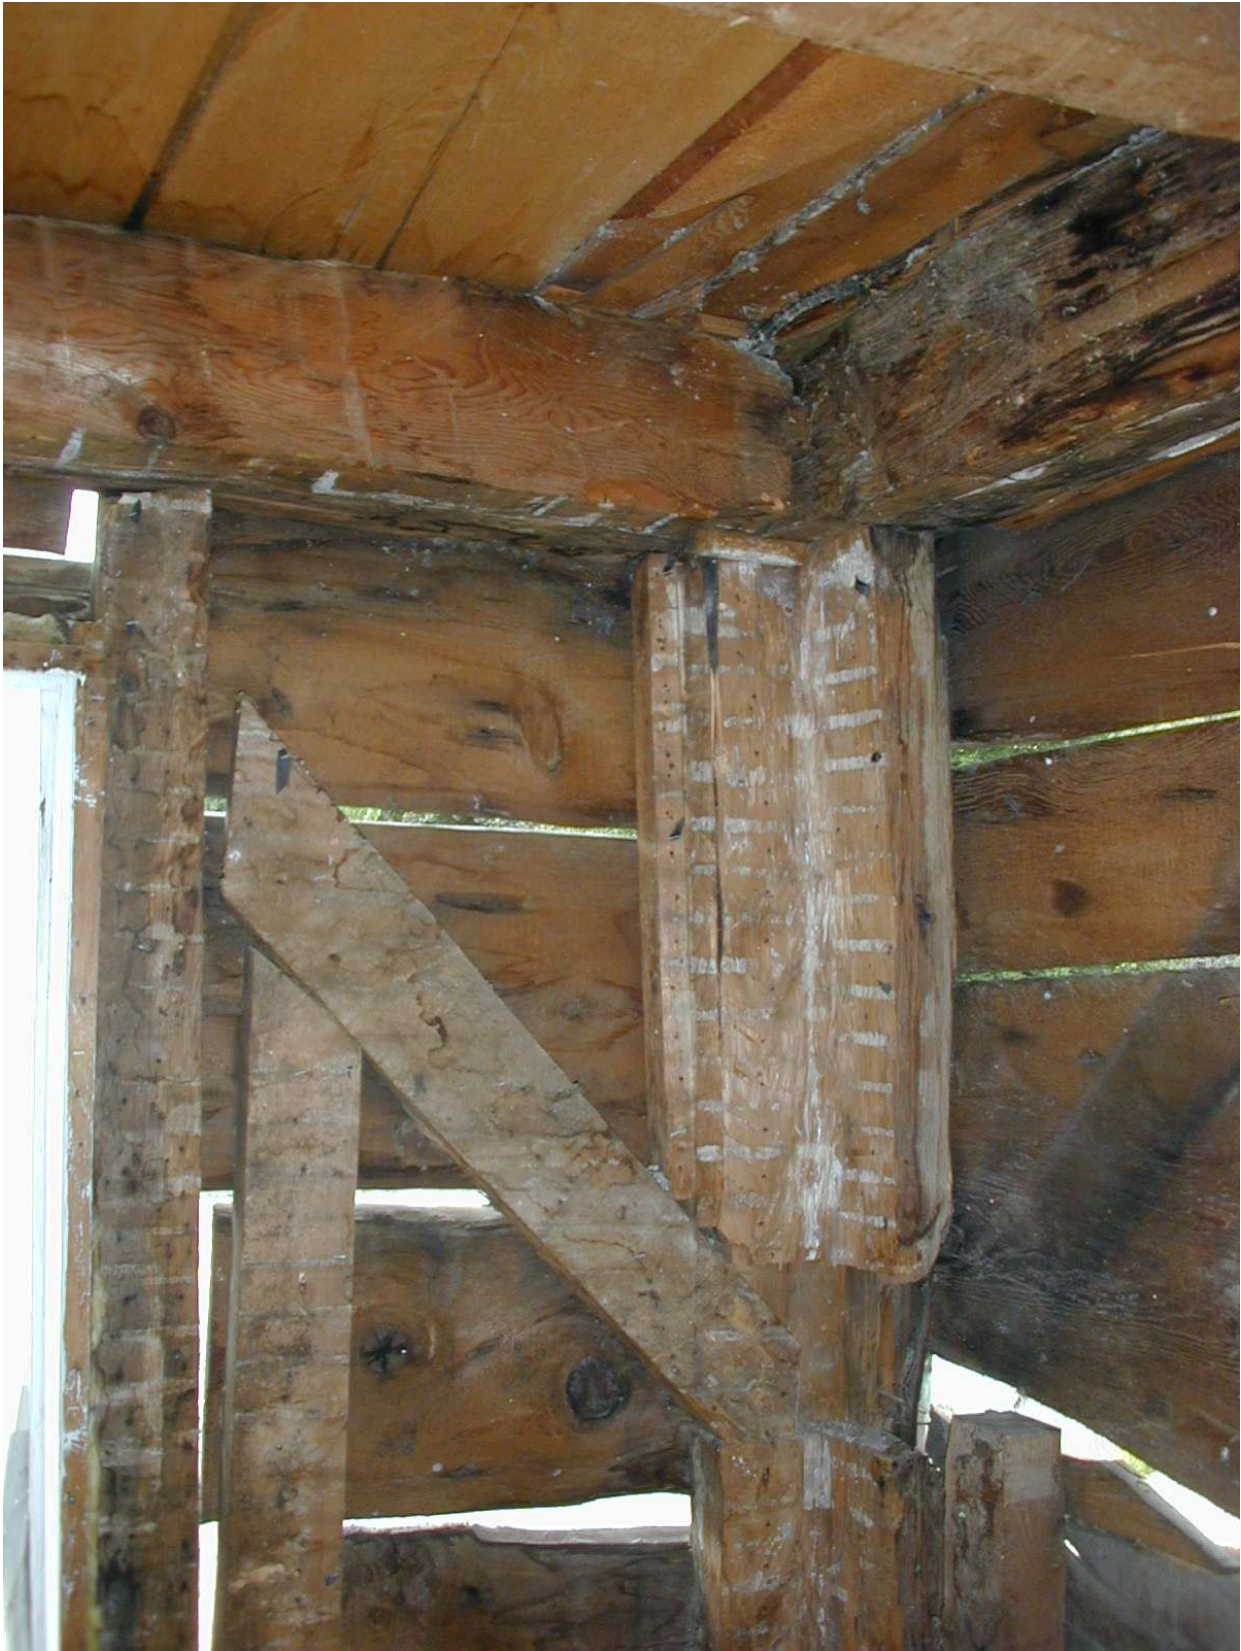
(E.) Re-worked corner post and wall bracing in older section of #925.

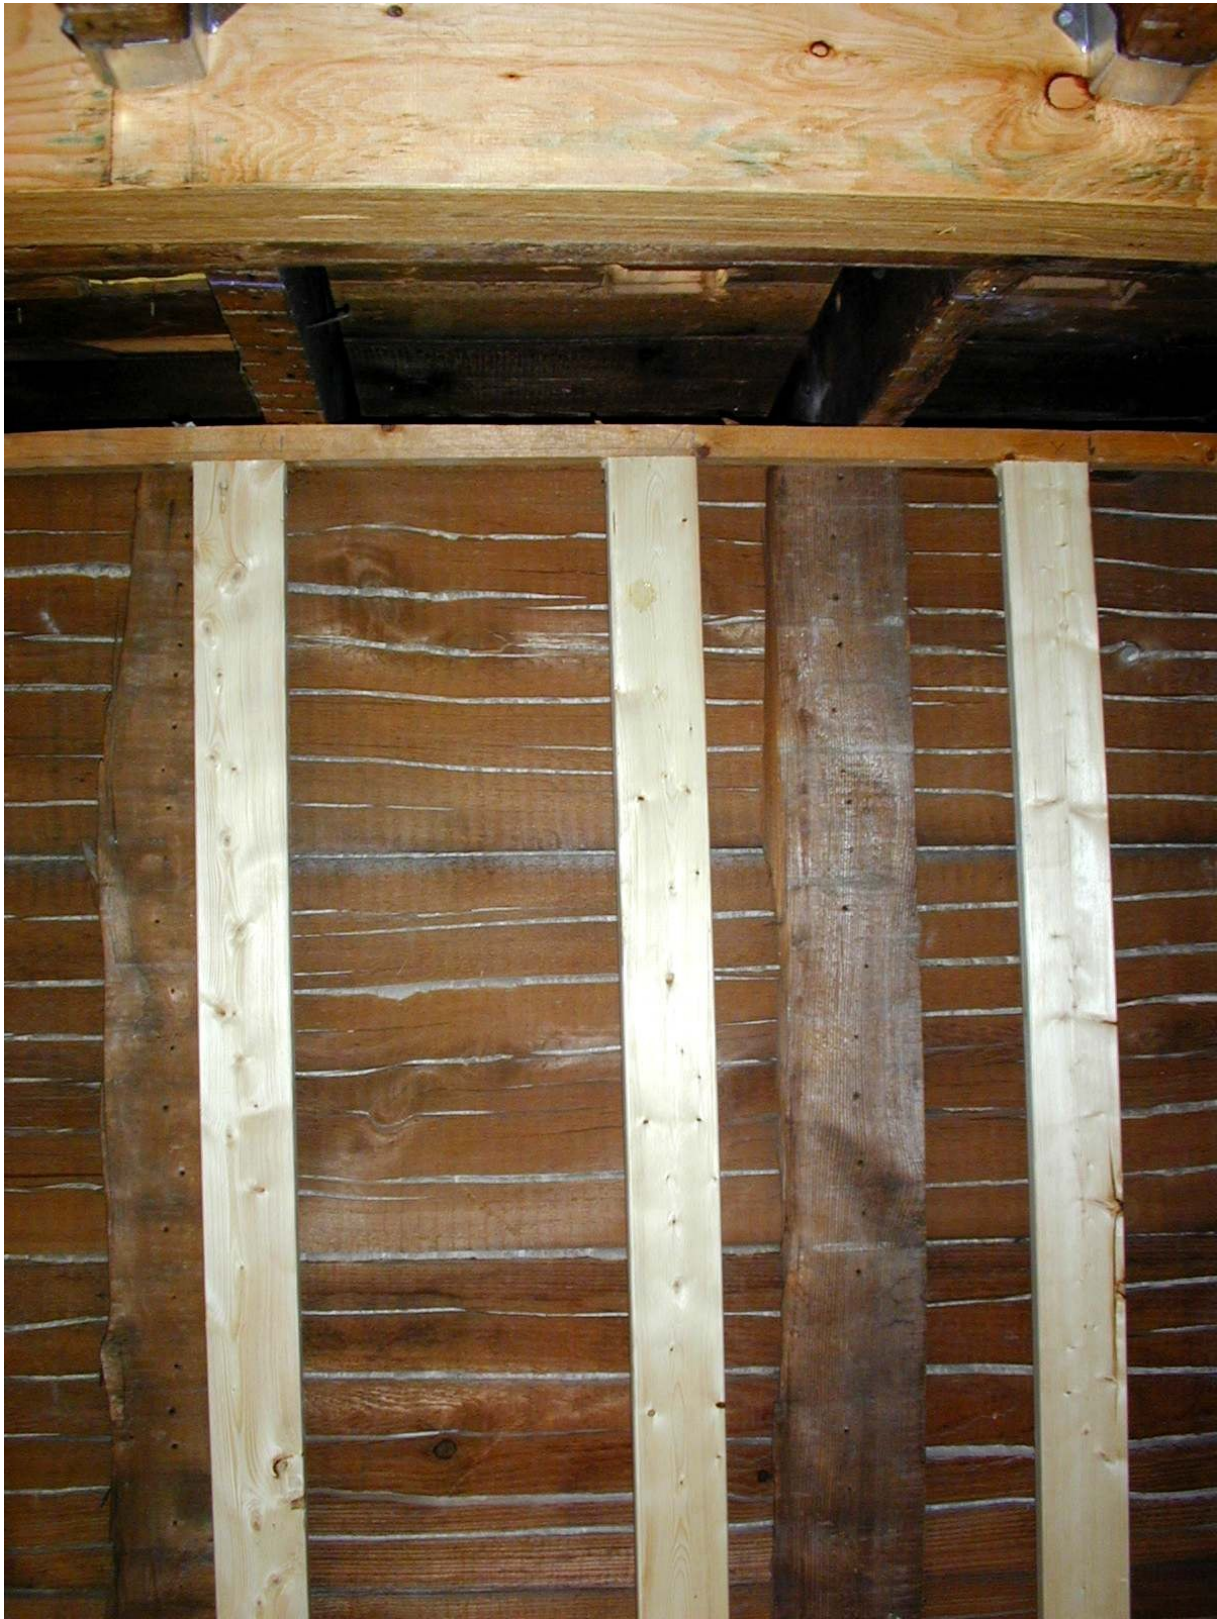
(F.) Hemlock split-board lath and oak ceiling joists in #929.

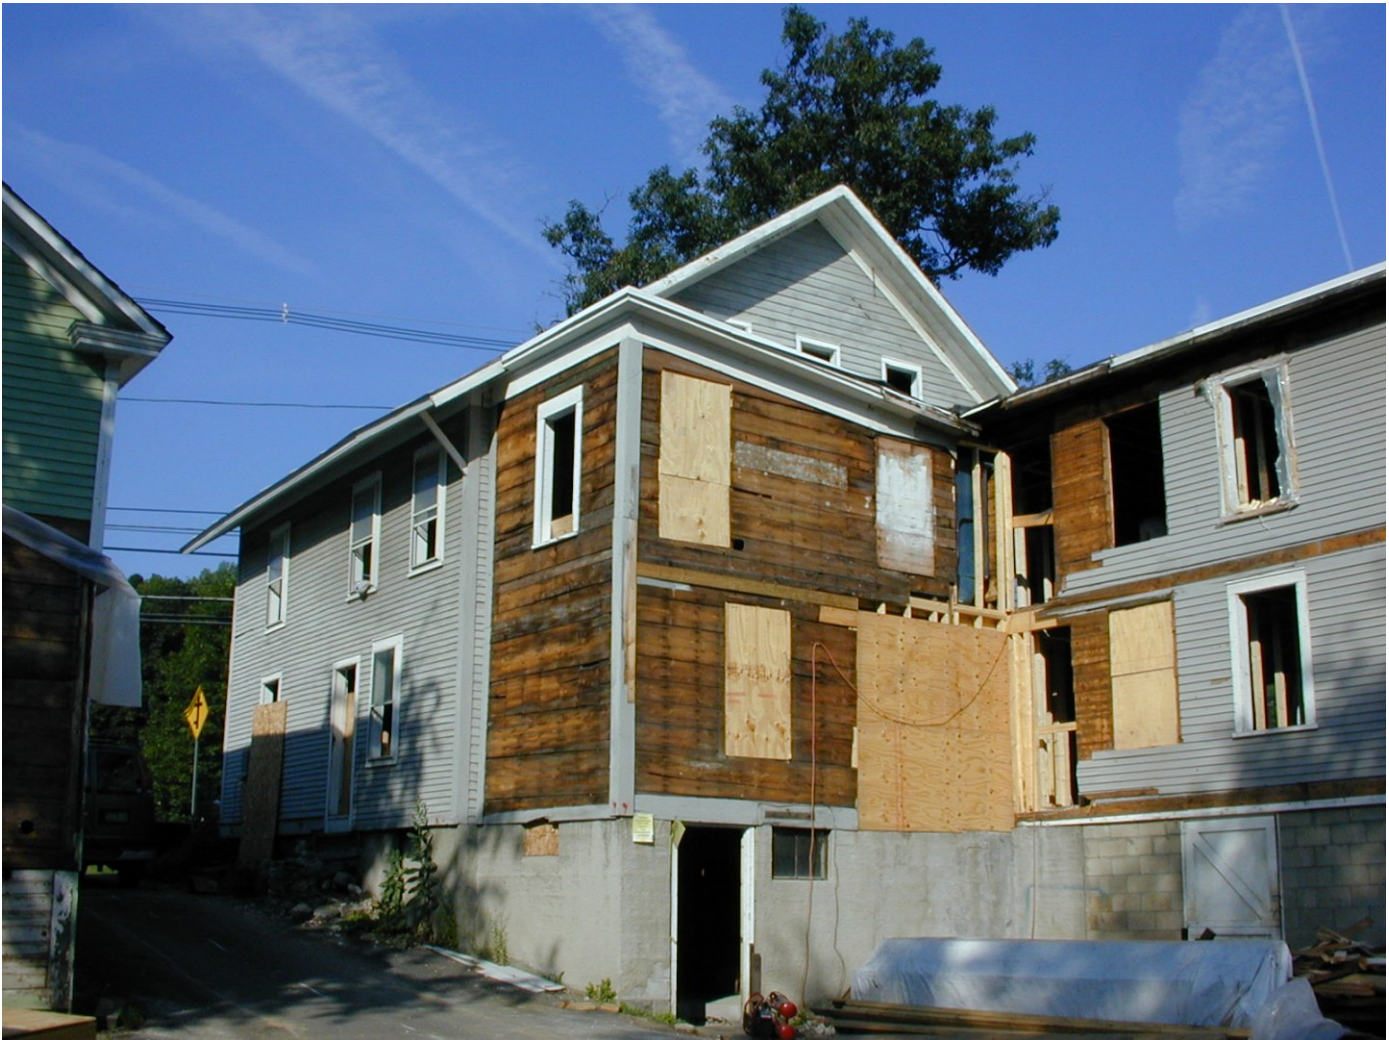
(G.) Rear view of #929. The three sections of the building can be distinguished: the front 2 ½ story section built in 1837, the 2 story rear wing possibly built in 1873, and the “shed” likely added between these two dates.

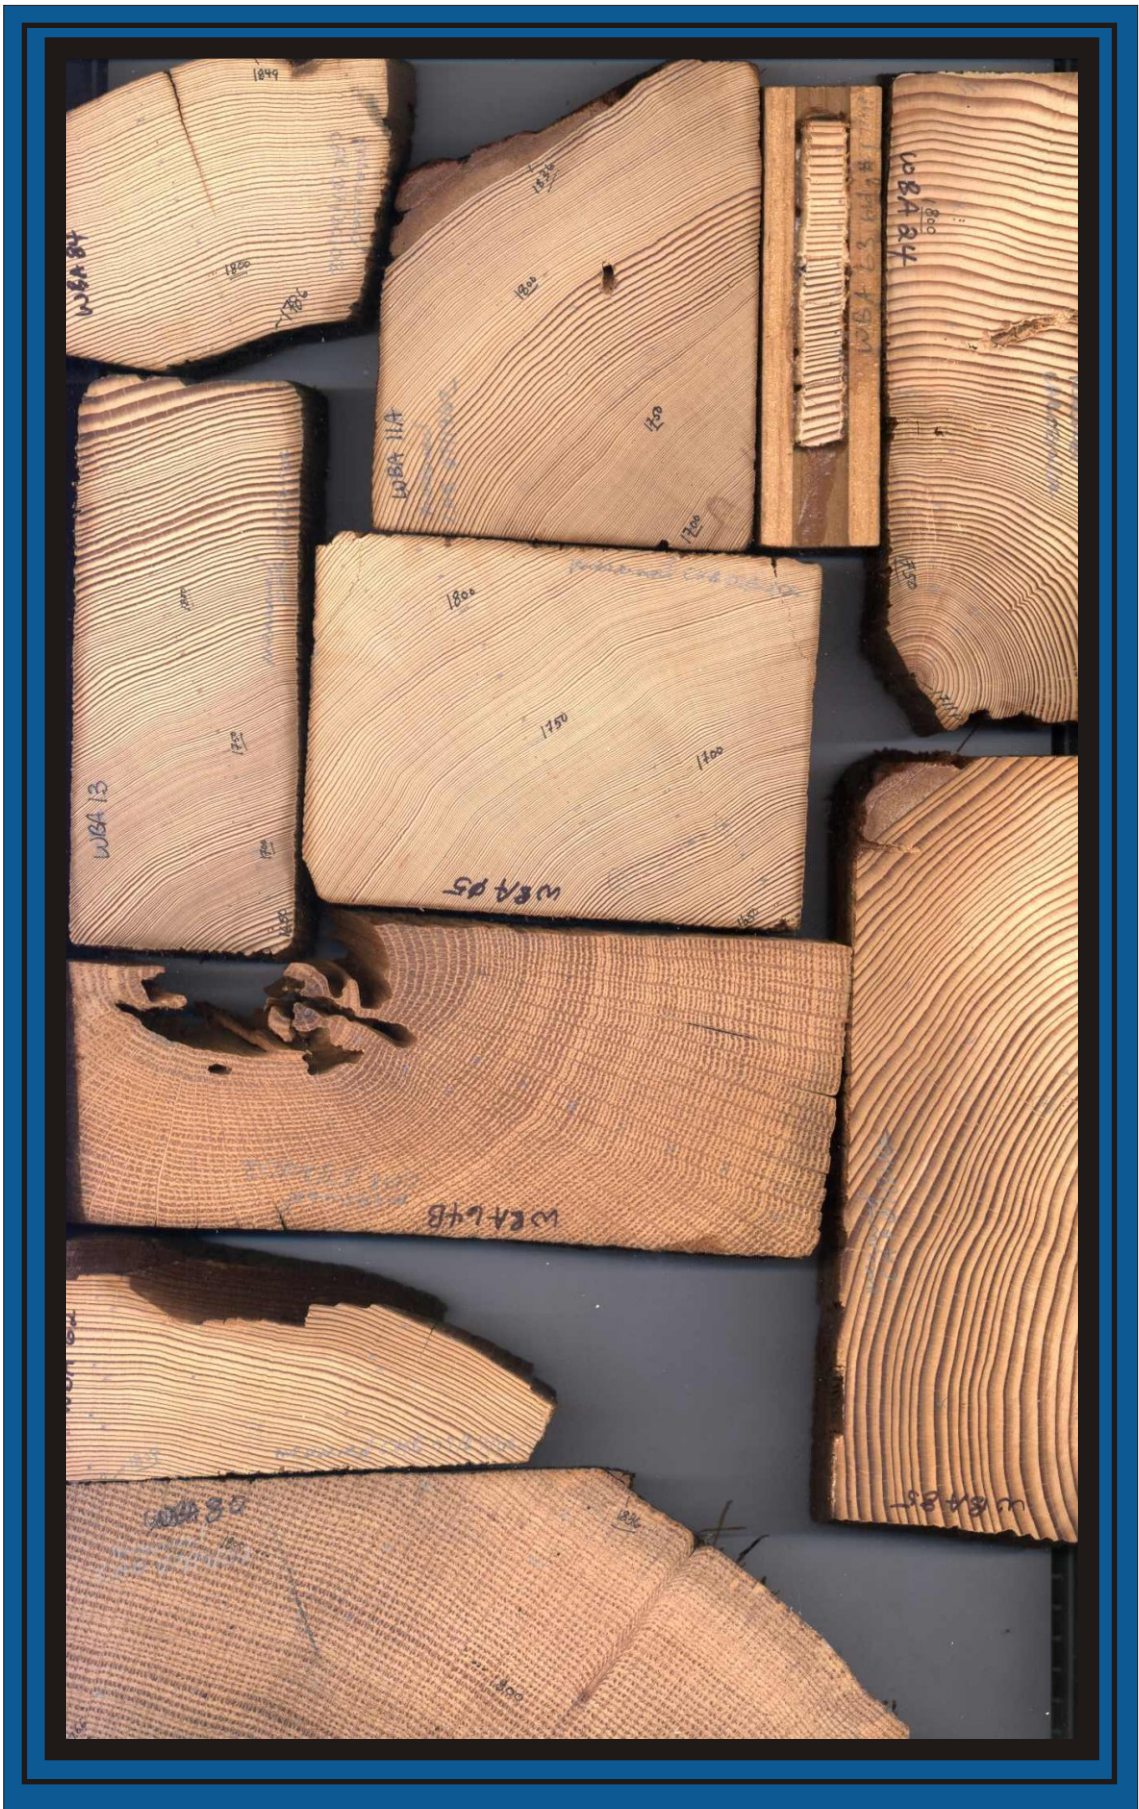
Samples collected from the West Brattleboro Apartments.
